The Durability of Shotcrete— Looking Back at Projects from 30 to 40 Years Ago

By Ted Sofis

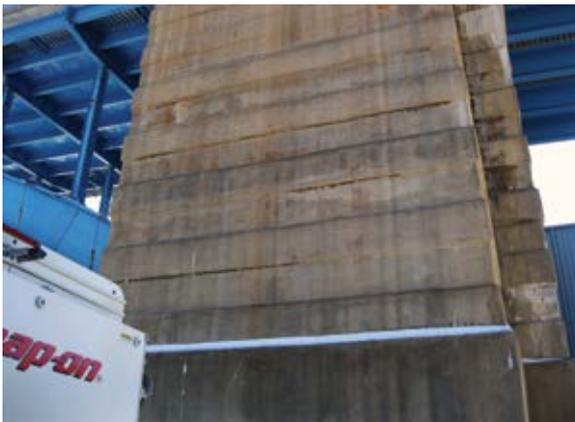
Fig. 1(a): Dry-process shotcrete repairs on 31st Street Bridge in Pittsburgh, PA, were done in 1973 over bottom two-thirds of this pier. Architectural details were maintained and shotcrete repairs remain in good condition 42 years after they were installed

The oldest of our projects that I revisited was the 31st Street Bridge in Pittsburgh, PA. The bridge spans the Allegheny River and Herr's Island, now referred to as Washington's Crossing. We were general contractor for the rehabilitation of the bridge and the work was done in 1973 and 1974. The project required steel repairs and extensive shotcrete repair work to the piers of the old bridge. The sand and cement was mixed on site with 3.5 ft³ (0.1 m³) of sand to one bag of cement. The mixture was measured in 1 ft³ (0.03 m³) wooden boxes as a quality-control measure. For the dry-process shotcrete placement, we used a Jetcreter, an early straight drop feed rotary gun. I remember the project well because I worked on the concrete tear-out crew during the removal stage and on the gunning crew during shotcrete placement. The most difficult part of the job involved cutting and finishing the architectural details on bridge piers. The bridge has undergone additional rehabilitation work in recent years for steel repairs and to replace the bridge deck, but the shotcrete installed on bridge piers 42 years ago remains intact and in good condition.

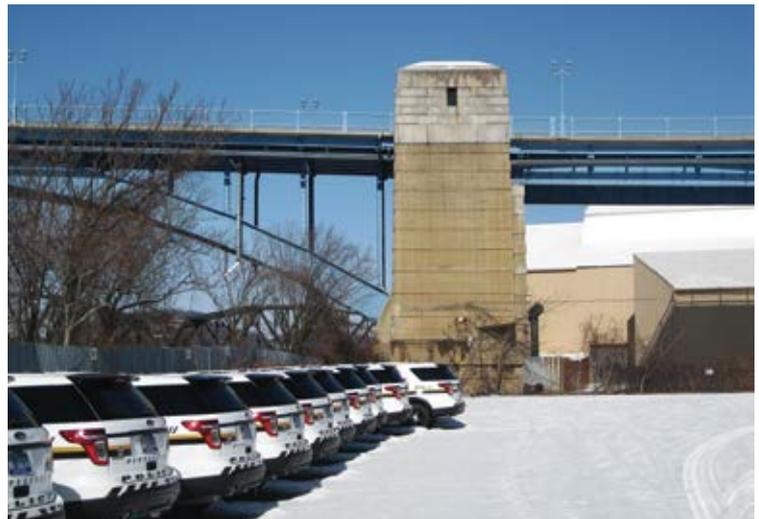
Fig. 1(b): This pier on Pittsburgh side of Allegheny River required extensive repairs and shotcrete also remains in very good condition

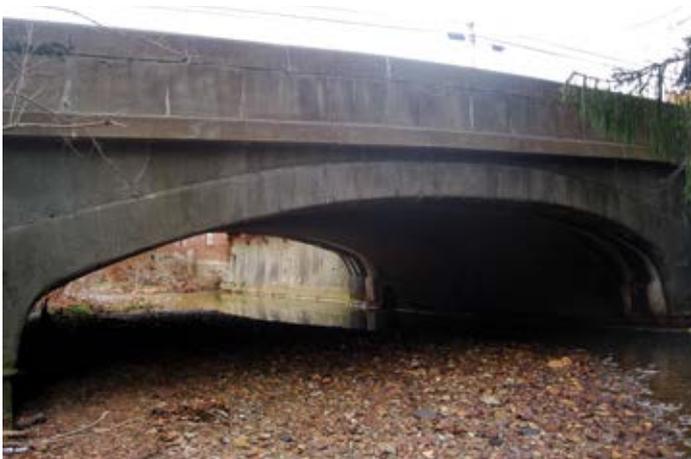
Fig. 2(a): Arches and parapets of this single-arch bridge in Bridgeville, PA, were badly deteriorated before shotcrete repairs in 1977. Dowels and reinforcing bars were installed and dry-process shotcrete placed across arches on both sides of bridge

The second job, in Bridgeville, PA, involved dry-process shotcrete repairs to a concrete arch bridge that we rehabilitated in 1977. On both sides of the bridge, the concrete arch was badly deteriorated. We removed the concrete to a depth of 14 in. (350 mm) from the edge of the arch. Because of the depth of the repair, dowels were installed across the entire arch and reinforcing bars were installed. In addition to the arches, the concrete parapets were also badly deteriorated. So the deteriorated parapet concrete was removed, leaving the capstones in place. The shotcrete was then gunned in place and finished to grade. Considering the condition of the bridge when the repairs were done in 1977, it is remarkable that after 38 years, it has held up so well. When shotcrete is placed properly, it's as durable as any concrete repair.

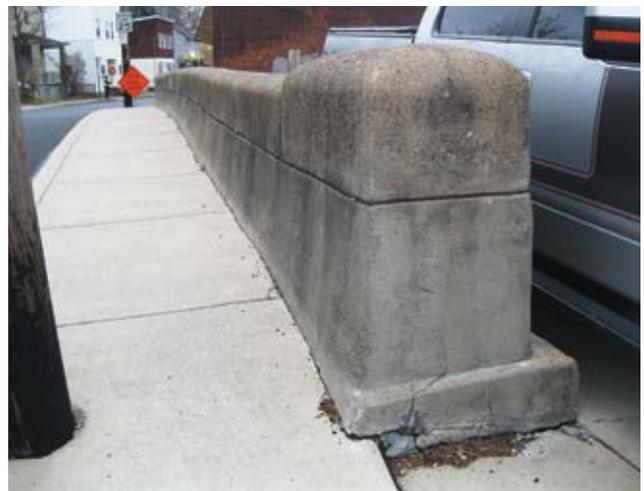
Fig. 2(b): Concrete on both sides of parapets under capstones were badly deteriorated. They were chipped out then replaced with dry-process shotcrete 38 years ago

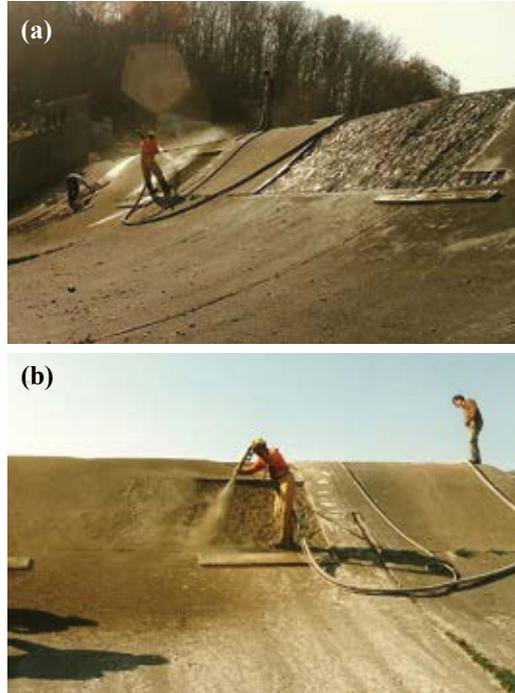
Fig. 3(a) and (b): (Before) Rehabilitation work on Raccoon Dam and Spillway (Raccoon State Park, PA) included removal and replacement of deteriorated concrete on large sections of spillway and across top of dam. These photos show dry-process shotcrete placed on upper sections of dam in autumn of 1984. Once placed, shotcrete was then cut down or rodded to grade before finishing

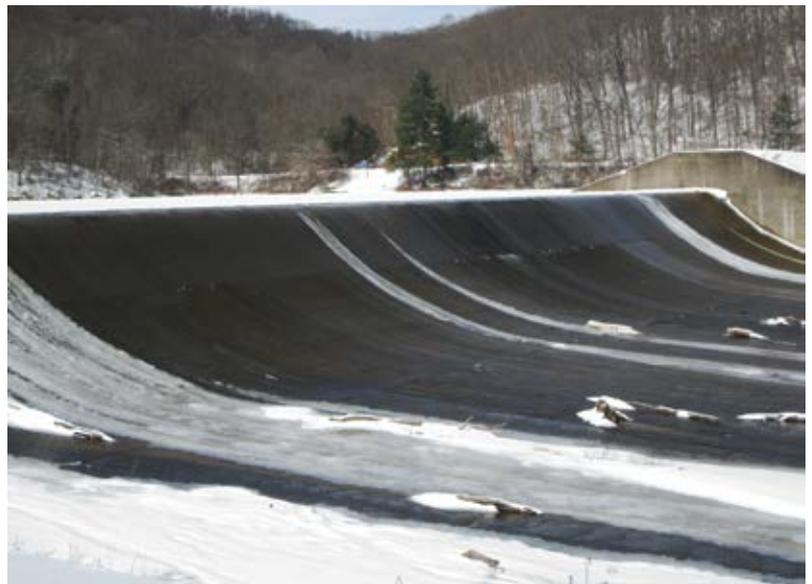
Fig. 4: (After) Shotcrete repairs to Raccoon Dam remain in good condition across crest of dam 31 years after shotcrete work was performed. Water flowing over crest of dam and spillway shows a relatively even flow despite the passage of years

perception of the owner's engineers was that polymer-modified patching mortar would give them a better job. After receiving our assurances, they allowed us to repair the crest of the dam with shotcrete. There were advantages to going with shotcrete. It was more efficient to transport the material through the gunning hose to the repair areas and we were able to gun the shotcrete to the full depth on sloped and vertical areas. In retrospect, it was the right decision. The shotcrete performed better than the polymer-modified patching mortar, and the shotcrete repairs have held up well over the years.

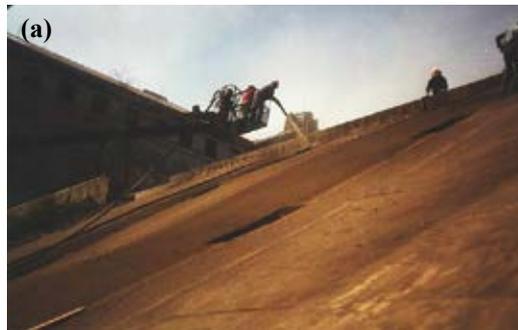
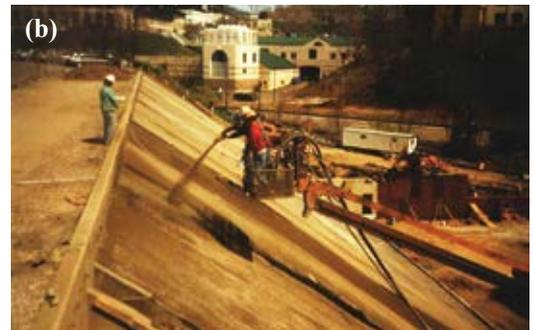
Fig. 5(a) and (b): (Before) In 1988, dry-process shotcrete was placed for slope stabilization on hillside behind Carnegie Museum in Pittsburgh, PA. Recesses were left for precast concrete to support a parking garage that was later built over the hillside

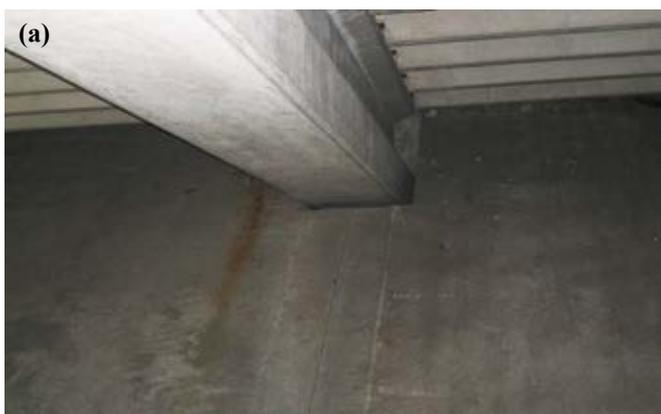
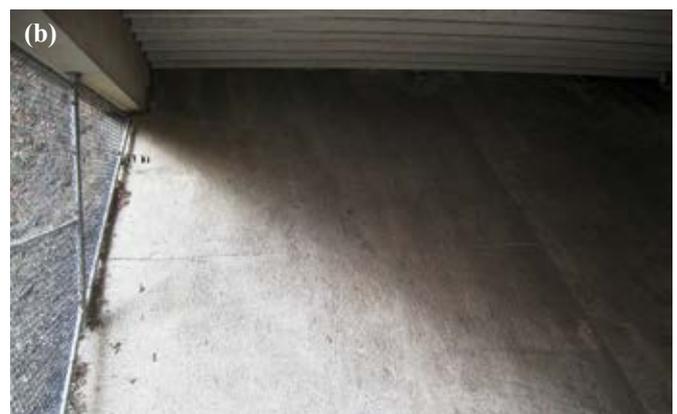
In 1988, we began placing shotcrete to stabilize the slope behind the Carnegie Museum in Pittsburgh, PA. The museum needed additional parking and the only land available was over the hillside in Panther Hollow behind the museum building complex. Because of the valley, a parking garage was designed to sit below the back of the museum and the parking structure was incorporated into the hillside. We installed the dry-process shotcrete in sections with regular expansion joints and screeded the shotcrete to fairly regular grade, giving it a cut-down finish. With the passage of time, the shotcrete remains in very good condition.

Fig. 6 (a) and (b): (After) Dry-process shotcrete was used to stabilize slope for parking garage that was built into hillside behind Carnegie Museum in 1988. These photos of that work taken in February 2015 (27 years later) show that work remains in good condition. Sections of shotcrete slope can be seen on each level of parking garage
